1. INTRODUCTION

This Post-Demolition Risk Assessment was developed to evaluate the health protectiveness of post-demolition site conditions at Parcel A of the Boeing C-6 facility in Los Angeles, California. Specifically, does Parcel A adequately protect the health of future users? Also, what are the health impacts, if any, associated with redevelopment of the parcel as a commercial/industrial facility?

Boeing C-6 Facility
Parcels A, B, and C

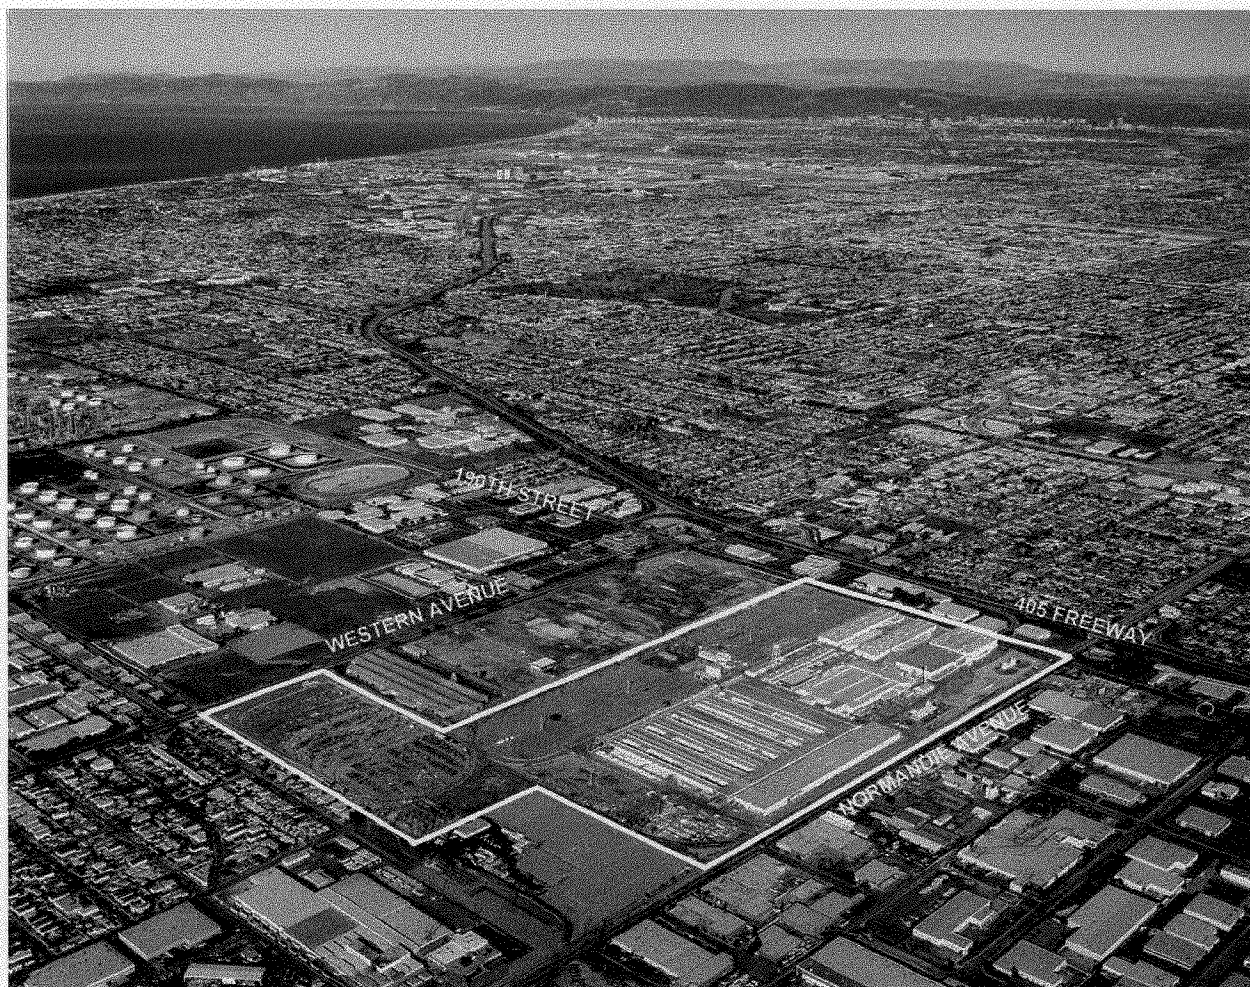
**FIGURE 1-1
BOEING C-6 SITE, LOS ANGELES, CA**

The 170-acre C-6 facility (Figure 1-1) has been used since the 1940s for industrial purposes but is currently undergoing a phased demolition and redevelopment. During each phase of the project, a post-demolition risk assessment will be conducted for the parcel undergoing redevelopment.

The C-6 facility (Figure 1-1) is located at 19503 South Normandie Avenue in Los Angeles, California, and is bordered by 190th Street to the north, Normandie Avenue to the east, 203rd Street to the south, and Western Avenue to the west. As shown in Figure 1-2, Parcel A fronts both 190th Street and Normandie Avenue.

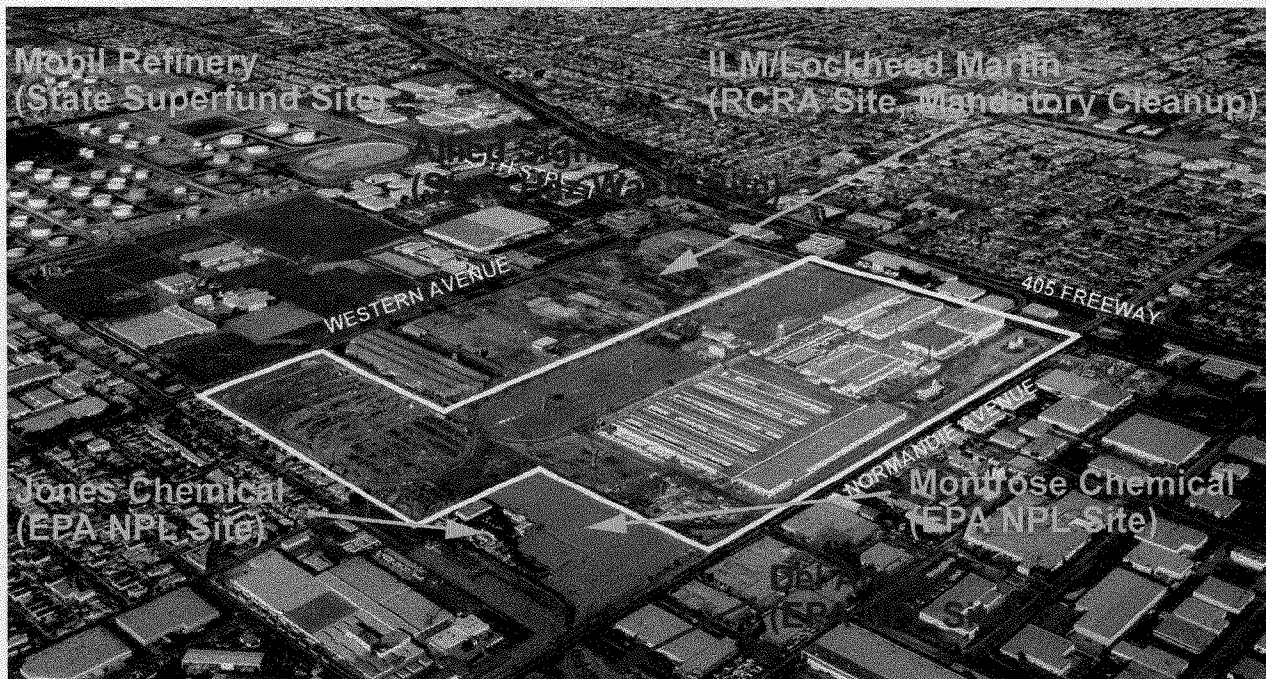
FIGURE 1-3
NEIGHBORING HAZARDOUS-WASTE-IMPACTED SITES

The surrounding area is characterized by a mixture of industrial, commercial, and residential land uses. Two National Priority List (NPL) Superfund sites and one California Superfund site border the C-6 property, while three other known hazardous-waste-impacted sites are within a half mile (see Figure 1-3).

Several of the properties adjacent to C-6 have undergone extensive environmental investigation and are known to have contributed to the regional contamination of groundwater in the area. The more environmentally significant properties include the Montrose Chemical, Lockheed Martin International Light Metals (ILM), and Del Amo sites.

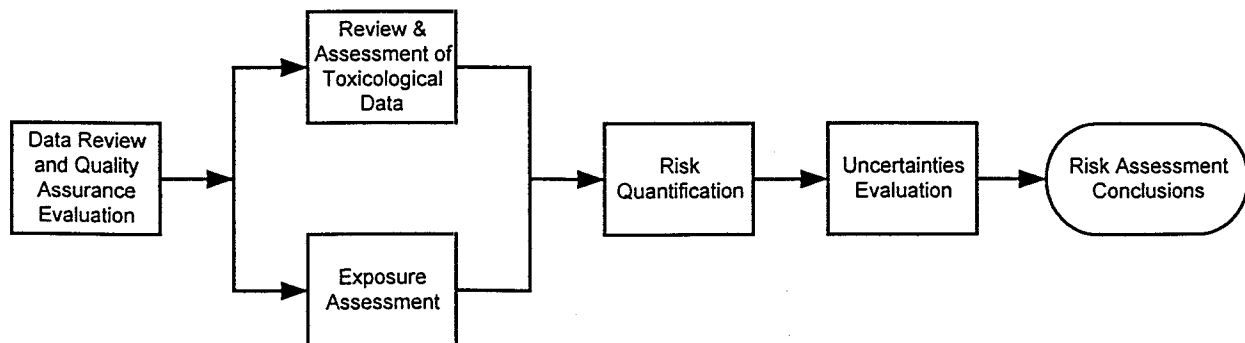
FIGURE 1-4
POST-DEMOLITION RISK ASSESSMENT PROCESS

As discussed, this post-demolition risk assessment evaluates the potential health impacts to human receptors associated with post-demolition site conditions at Parcel A and the proposed development of the parcel as a commercial/industrial facility. As shown in Figure 1-4, the risk-estimation methodology consists of six distinct steps, some of which may be performed concurrently.

First, the post-demolition data associated with Parcel A were reviewed and the analytical results compiled. The data were screened according to data usability criteria established for risk assessment. Of the data meeting these quality criteria, constituents of potential concern (COPCs) were selected based on frequency of detection, mobility, and persistence.

Second, those COPCs for which EPA toxicity data exist - as published in the California Cancer Potency Factors Update, Integrated Risk Information System (IRIS) or Health Effects Assessment Summary Tables (HEAST) - were selected for risk analysis. For COPCs without such toxicity data, health-based evaluations could not be completed.

In Step 3, comprehensive post-demolition exposure scenarios were developed that describe the potential exposures at Parcel A and provide a basis for quantifying those exposures. Each exposure scenario was developed to address the source of residual COPCs, route or mechanism of exposure, and potentially exposed populations (known as "receptors"). When site-specific data for scenario development were unavailable, conservative values found in the literature were used.

In Step 4, the toxicity and exposure assessments were summarized and integrated into quantitative expressions of risk. Specially designed spreadsheets were developed to calculate COPC-specific, multipathway risks for each of the Parcel A receptors.

Usually, the risk values presented in a risk assessment are not fully probabilistic estimates of risk but conditional estimates given a considerable number of assumptions about exposure and toxicity. Thus, it is important to fully specify the assumptions and uncertainties inherent in the risk assessment to place the risk estimates in proper perspective. This process is conducted in Step 5.

Step 6 involves the development and presentation of conclusions that can be inferred from the findings of the risk assessment. This step is useful in providing risk managers insight into the interpretation of the risk assessment results.
